# **Note on OPERATION ANANTHA - Flood control of Thampanoor from May 2015 till March 2016**

The project "OPERATION ANANTHA" was launched in the month of May 2015 as a permanent solution to the flooding problem, starting with the Thampanoor-Eastfort area, within the capital city of Thiruvananthapuram. Later, because of public demand, this was extended to areas like, Karimadom colony - Yamuna Nagar - Aryashala, Kariyila thodu near Enchakkal, Pattom - Marappalam area and Technopark. The project not only evicted encroachments over the Amayizhanchan thodu and several long forgotten drains by the side of roads over a total length of around 30 kms, but widened such drains / canals to a width of 2 - 4 metres. The flooding at the Thampanoor central Bus Depot and Central Railway Station as well as the busy East Fort City Bus Stand area was a nightmare to the passengers. Even on the onset of the lightest rains, the 3 stations, which are the main transport hubs of Thiruvananthapuram city, got submerged for hours together.

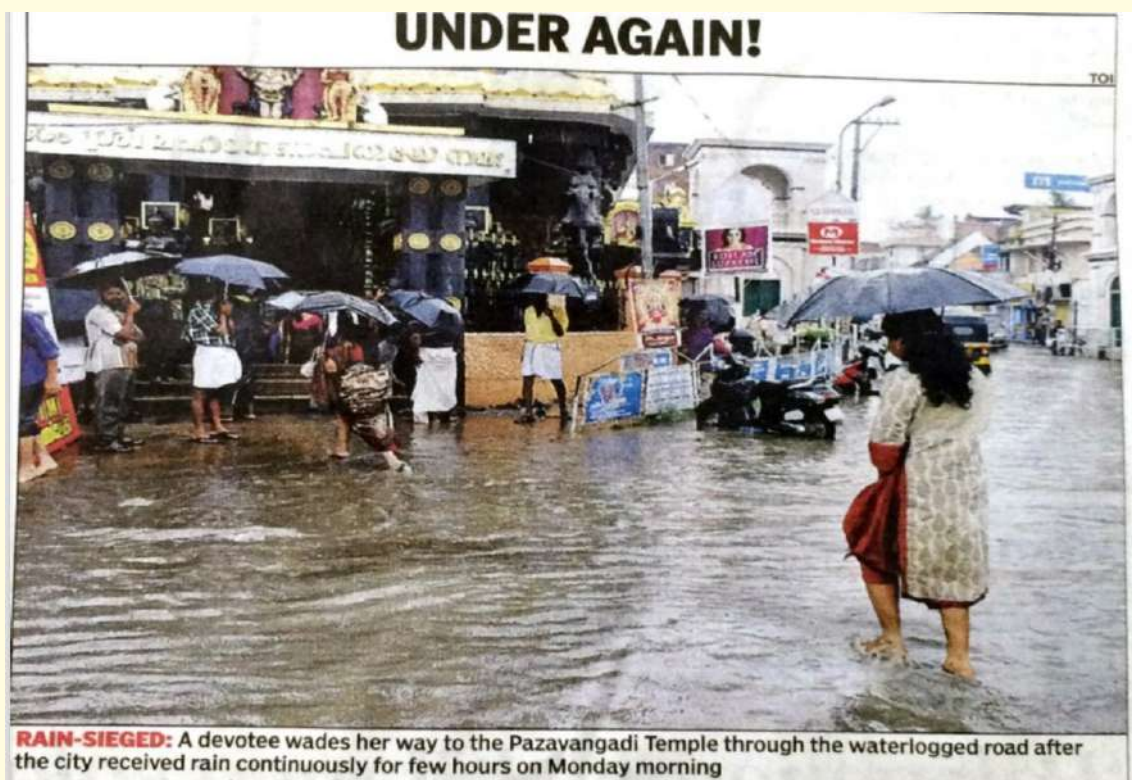
Figure 1 East fort during floods

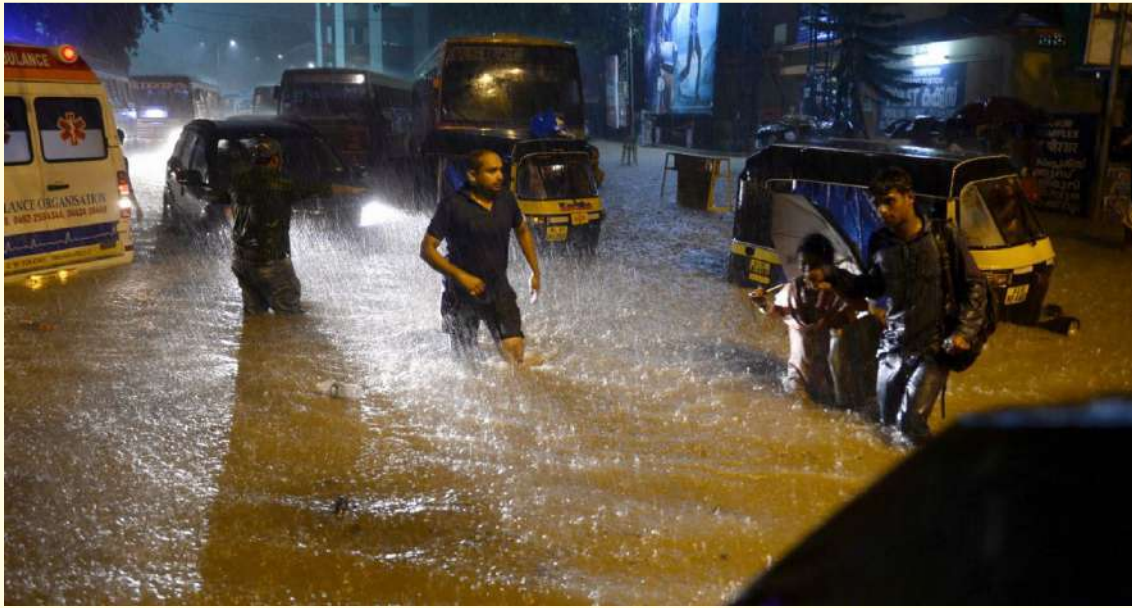
Figure 2 Thampanoor during rains

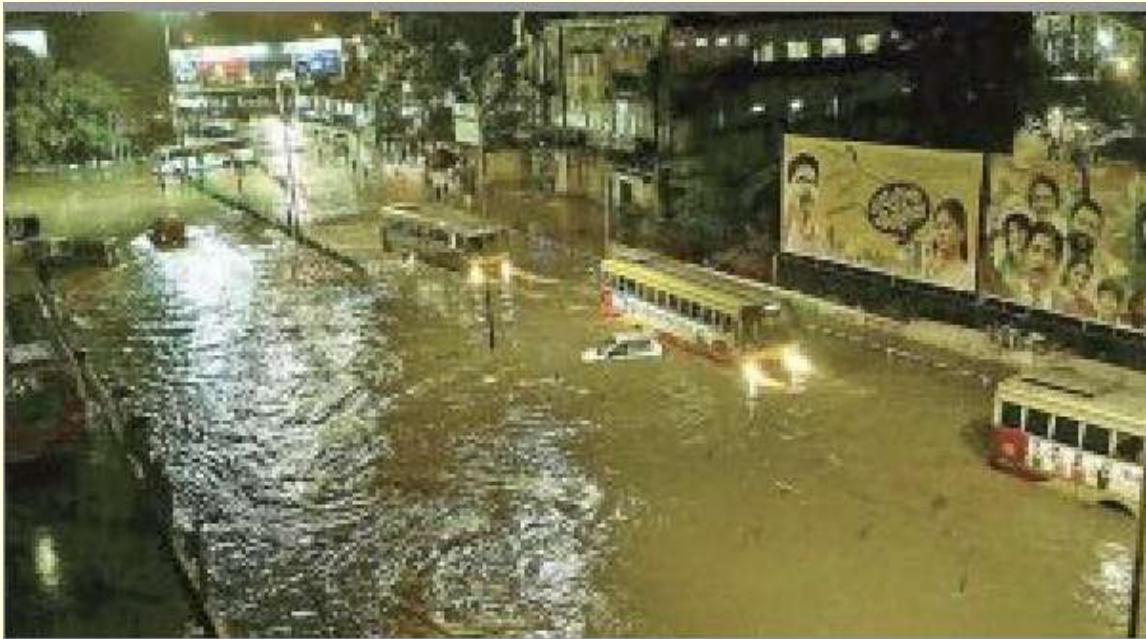
Figure 3 Thampanoor during floods

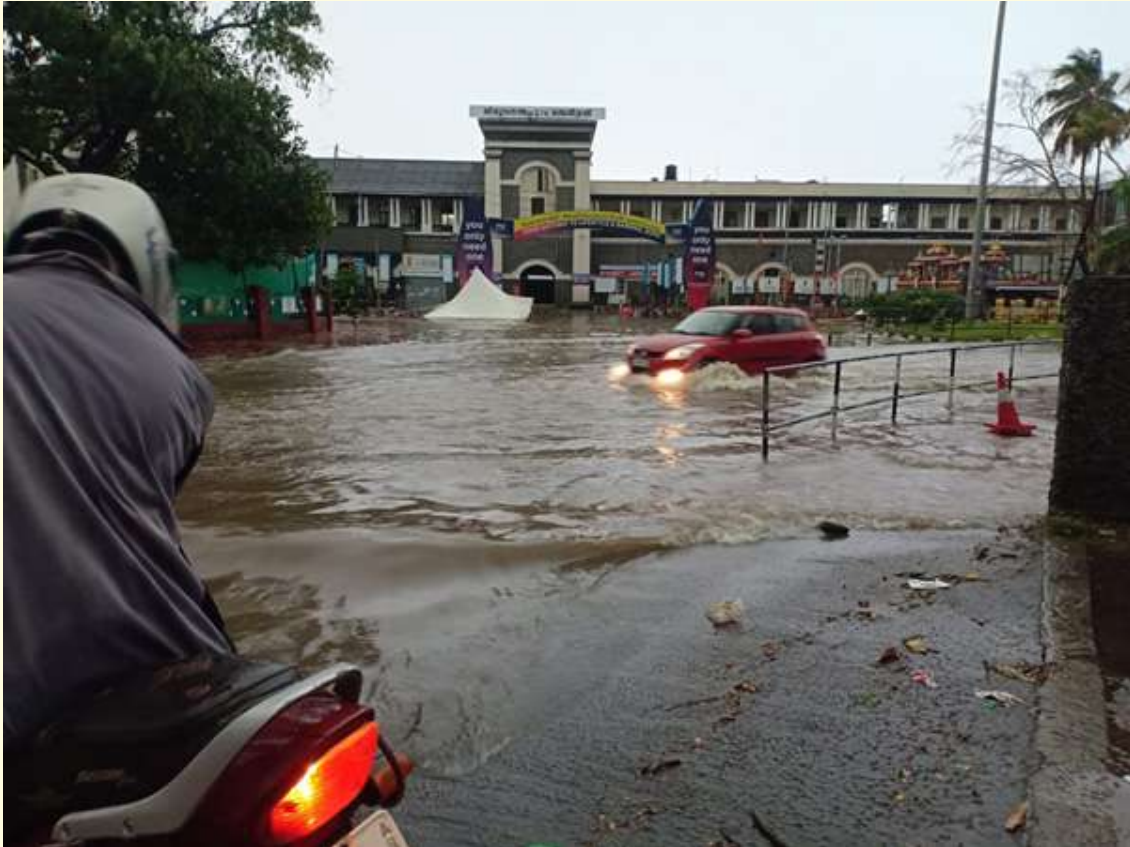
Figure 4 Thampanoor during floods

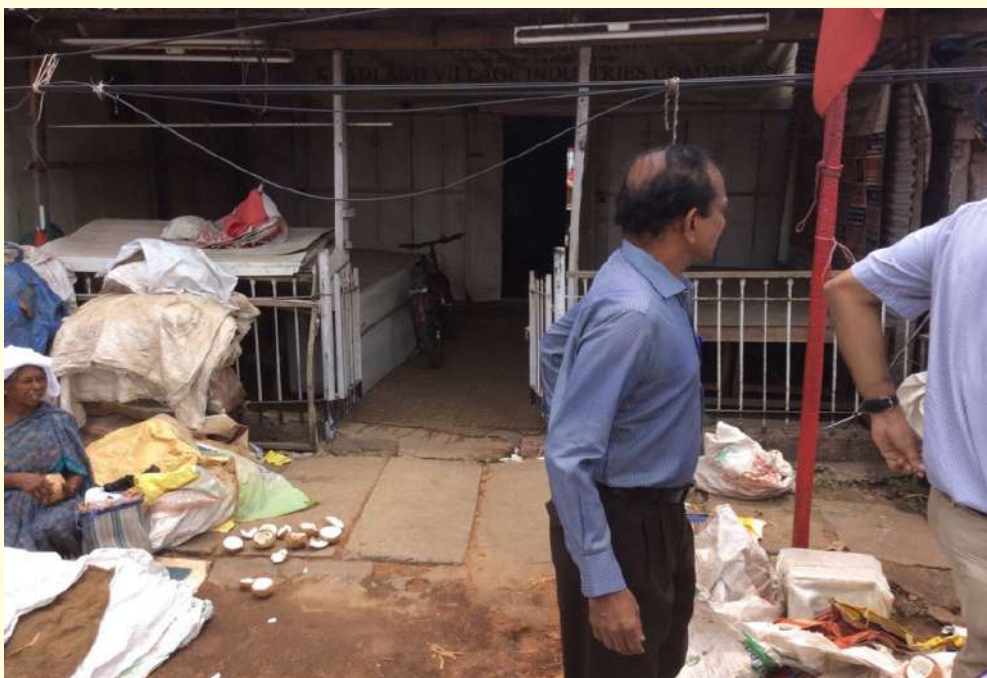
Figure 6 a shop on top of the drain

1. The first and foremost among there was the widening of the Amayizhanjan Thodu in the stretch from Bakery Junction to Thampanoor. The width could be increased to over 3 meters in most of the sections. There were two major constructions by private agencies which actually restricted the flow of water due to encroachment. These structures were demolished using heavy duty equipment. This ensured free flow up to the entrance to box culvert inside the

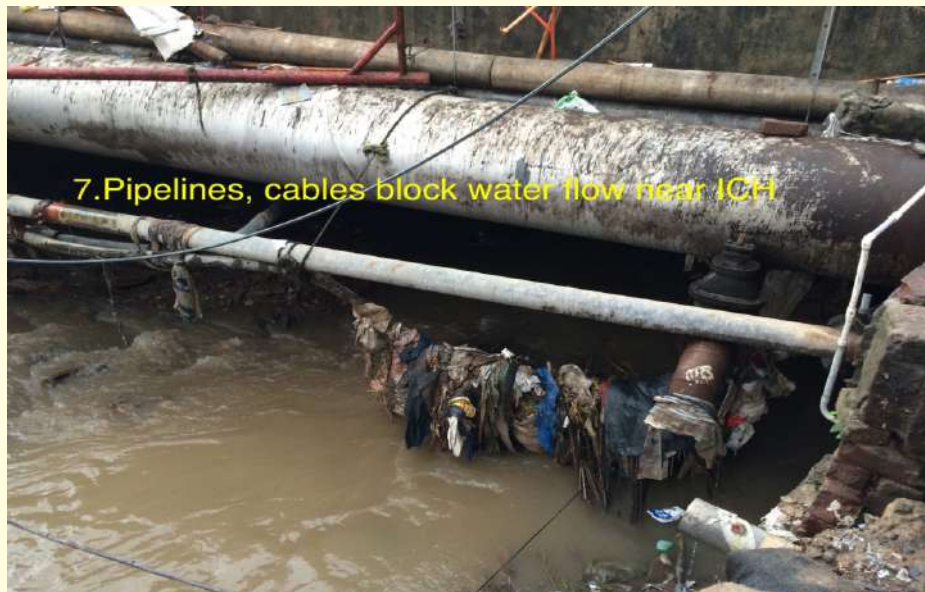
Figure 7 Pipelines blocking near Indian Coffee House

There were two major reasons for the flooding in the Thampanoor area. The first reason was that the free flow of water through the Thodu near the Indian Coffee House (ICH) in Thampanoor was obstructed by several pipelines installed at various points, crossing the the Thodu. The second major reason is the accumulation of large quantity of wastes, sludge and filth within the box culvert underneath the railway lines preventing the free flow of water. On the southern side of railway station, at the end of the box culvert under railway lines, near the station gate, there existed the remains of, presumably, a pile foundation of size 2m X 3m X 1m. This structure has actually prevented the flow, and solid wastes and sand carried by the stream got accumulated at this point and finally reduced the speed of flowing water. This was the major contributor to the water logging problem in Thampanoor area. Beyond these concrete blocks, the water channel does not possess the required depth, as the sand and sludge accumulated were never removed, even today.

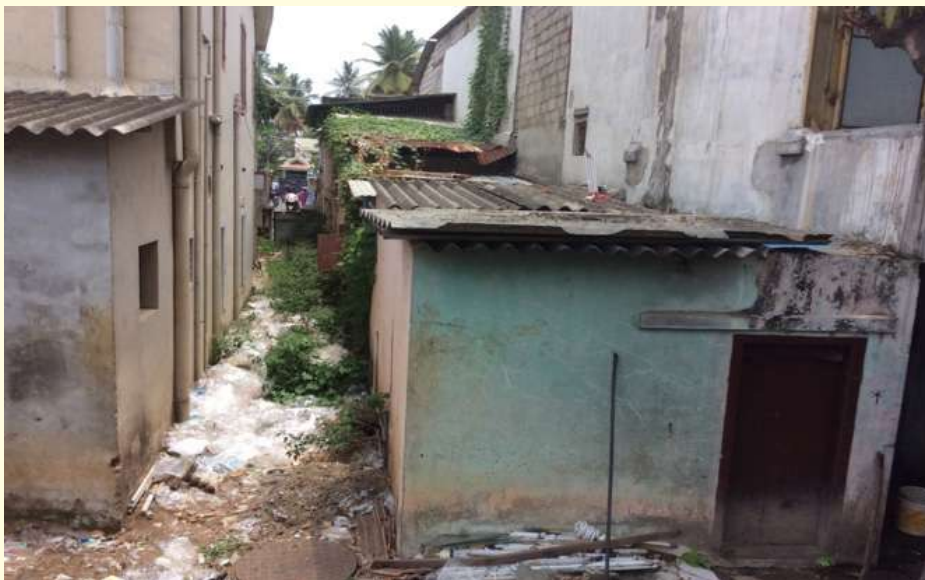
Figure 8 illegal construction on top of filled up drains

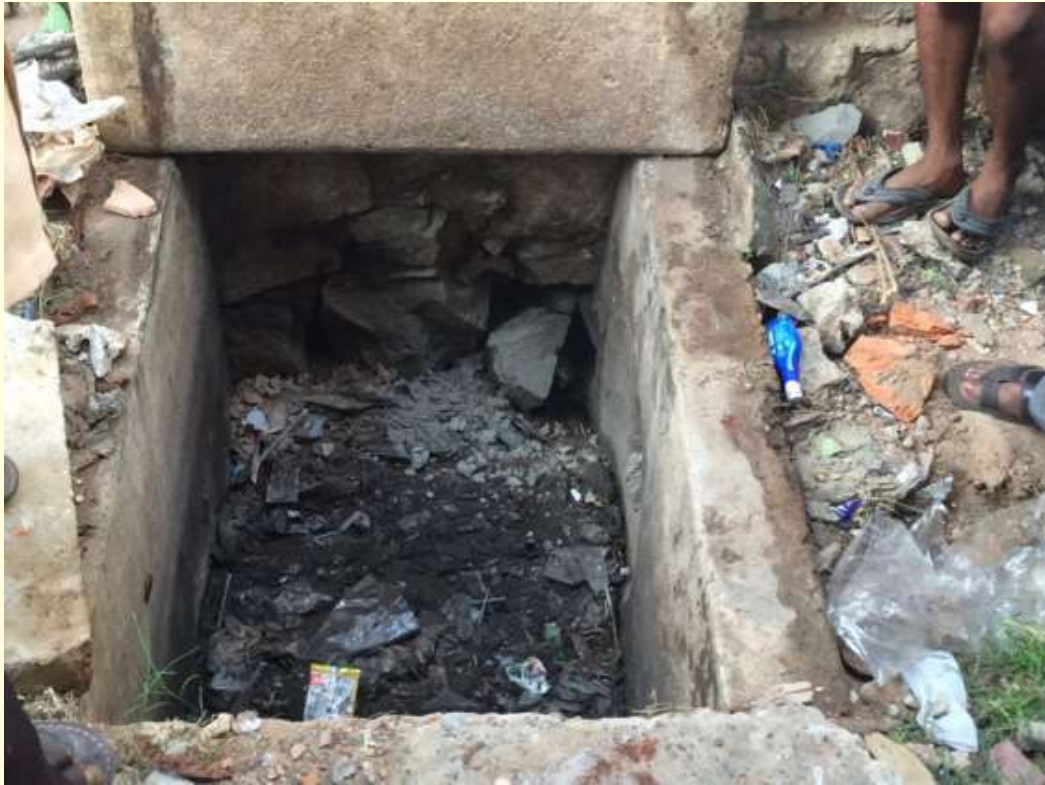
Figure 9 Blocked drains due to foundations of buildings inside drain

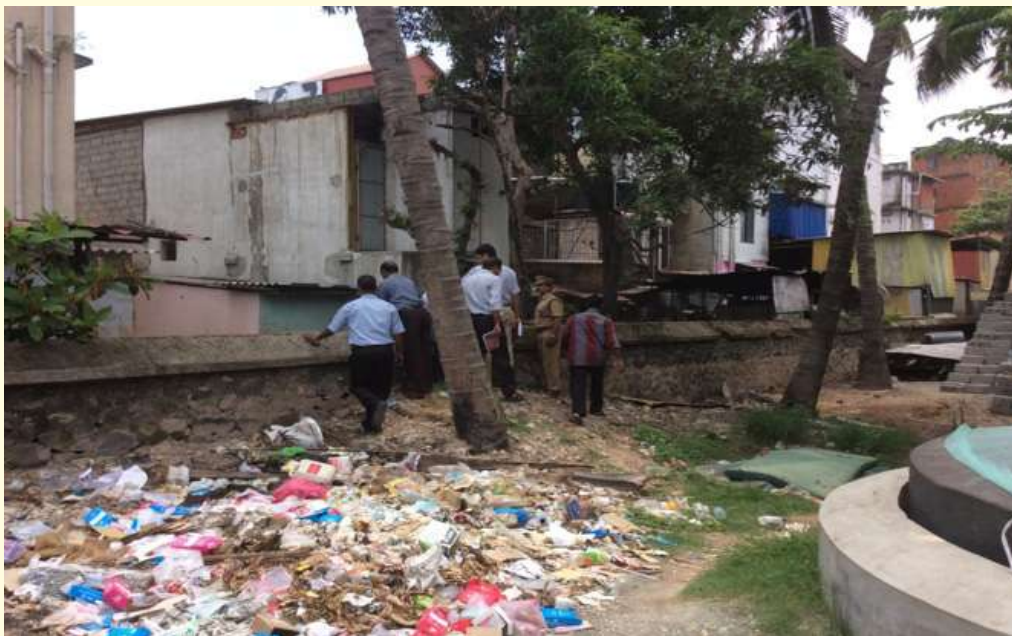
Figure 10 Buildings on top of the filled up drains

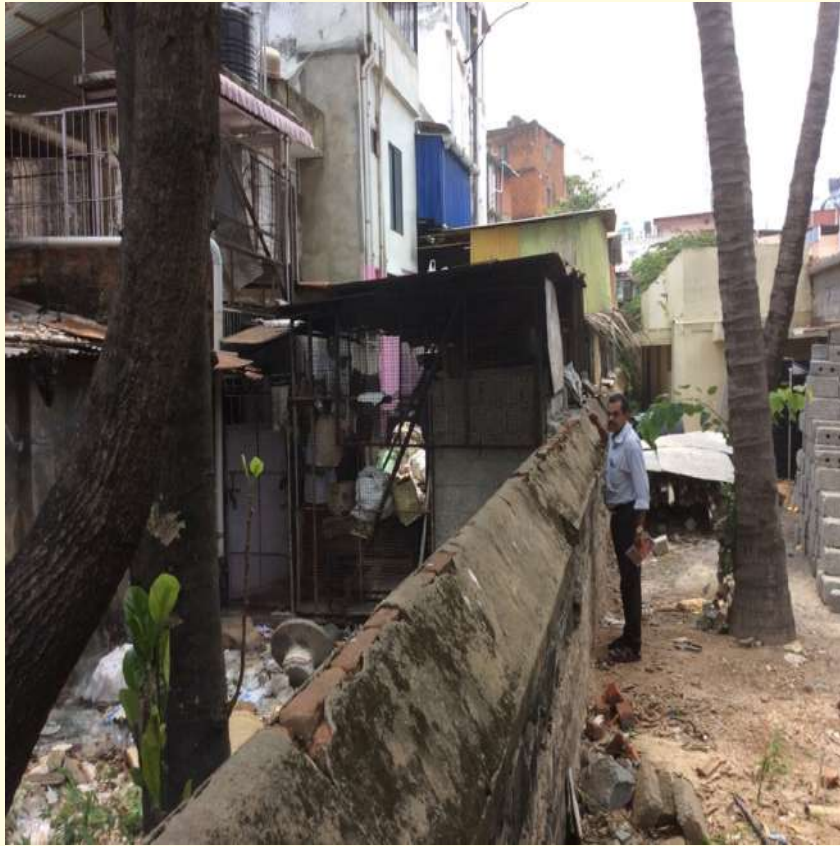
6. Behind the Ganapathy Kovil temple, the entire stretch was covered with earth and there was steel shed with two huge generators of a textile shop installed therein.

Figure 11 the green building is a generator room on top of drains

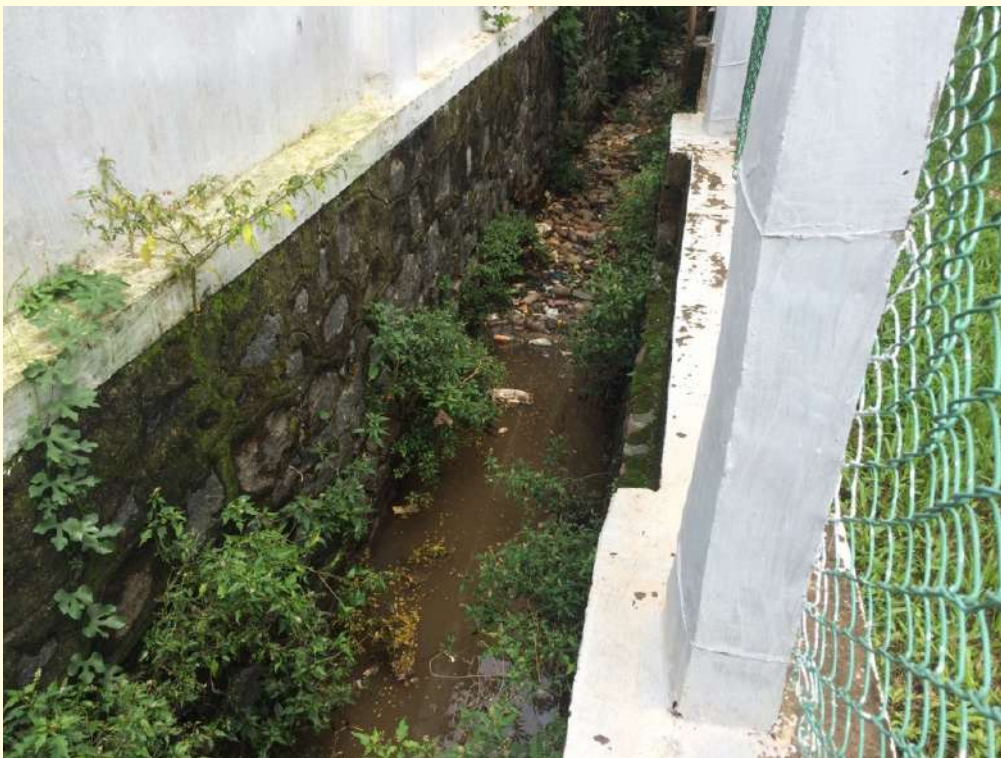
Figure 12 the remanants of old bypass canal connecting Amayizhanchan and Thekkinakkara canals

Therefore, PWD was asked to construct an overflow duct of 2 m x 2 m cutting right across the Putharikandom maidan, connecting the remnants of old canal at south side of the maidan to the big thekkinikara canal.

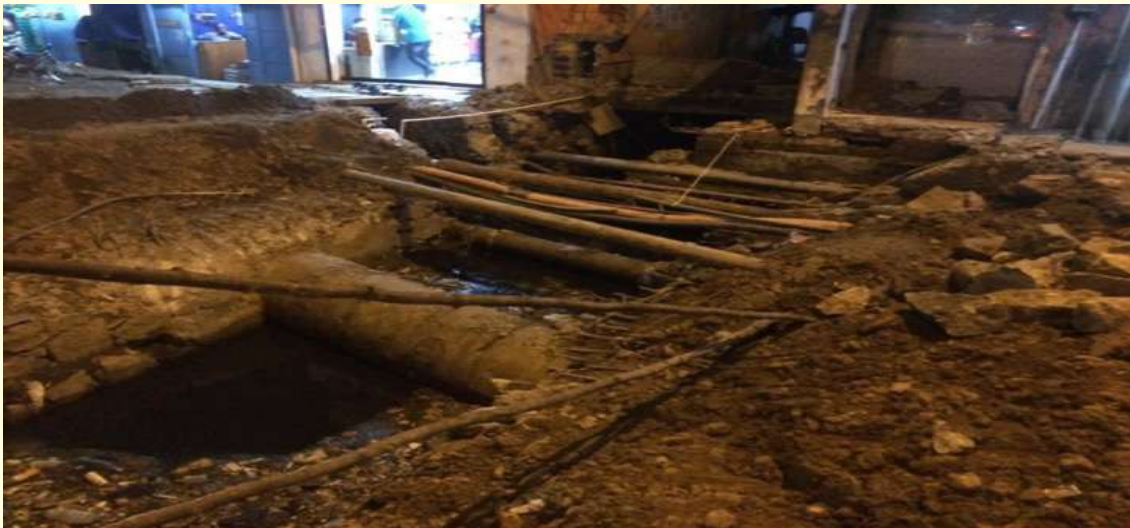
Figure 13 Pipe lines crossing drains at attackulangara

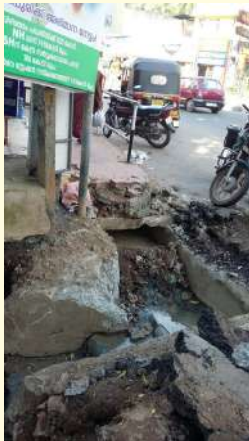
Figure 14 Drains chocked with deposited sand and debris

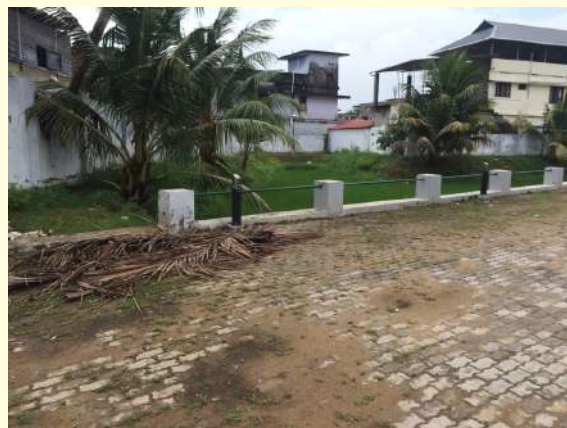
These two canals do not have adequate capacity to hold large quantity of water received during the rainy days. Originally, Putharikkandom Maidanam was remaining as paddy field and has been acting as a floodplain. During those days, the overflow of water from the Amayizhanjan thodu was collected in these paddy fields and acted as a reservoir (room for river). Further, the excess water from the paddy fields was flowing to the Thekkinikkara canal crossing the Chala Road through another small canal. However, the remnants of this water flow path continued to exist on the southern side of Putharikkandom, as a narrow stream, but no connectivity offered by the raised ground of Putharikkandom maidan. The free flow of water from Amayizhanchan Thodu was obstructed consequent to the conversion of the paddy fields into Putharikkandom Maidanam into a convention ground, forcing whatsoever quantity of water from Thampanoor to flow through only the amayizhanchan thodu to Pattoor and KunnuKuzhi to ultimately reach the Parvathi Puthanar river.

Figure 15 what is left over as the Putharikandom (paddy fields)

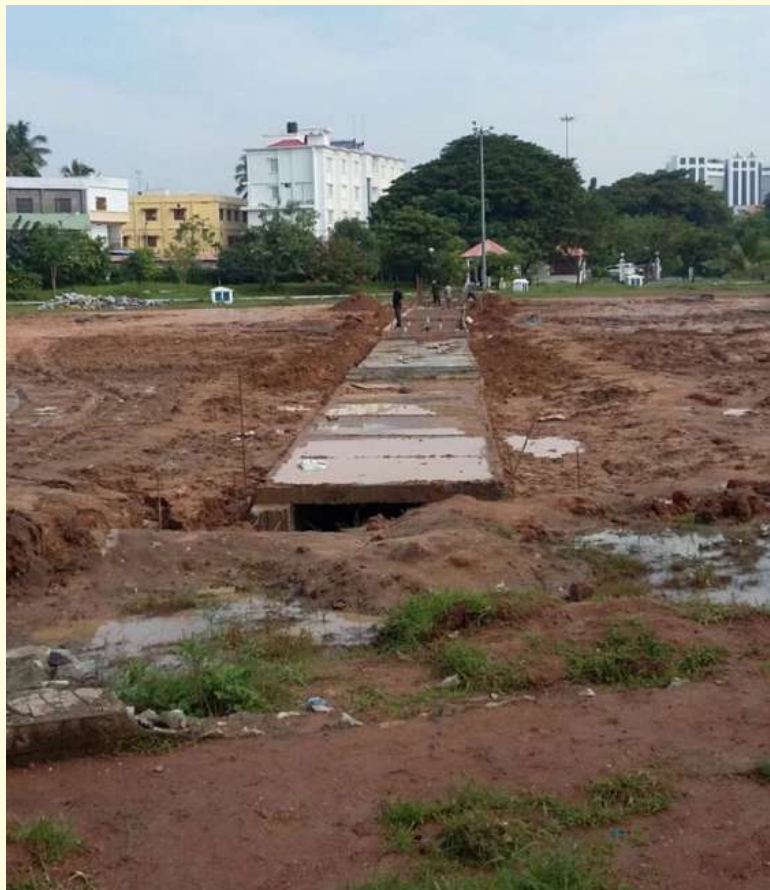
This over flow duct was designed in such a way that water flows inside only when overflow from amayizhanchan thodu happens, through the opening of the duct. The opening to overflow duct is located around 2.5 mts above the bottom level of the thodu. This duct opening is near the Central Theatre and when water level rises, the excess water flowed smoothly to Thekkinakara Kanal.

Figure 16 The overflow duct constructed to connect amayizhanchan and Thekkinikara canals

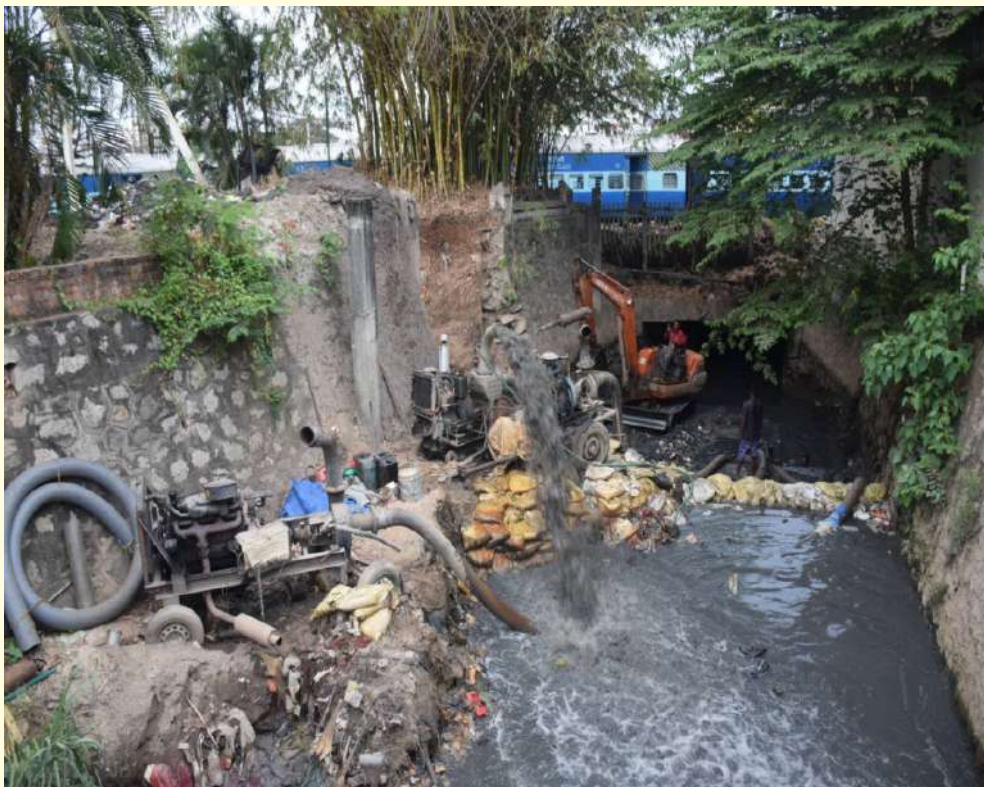
The various measures implemented during the Operation Anatha – I, prevented flooding at the Thampanoor area. These initiatives have also served as a solution to the water logging problem at the East Fort area. But the raised bed level of the Amayizhanchan thodu from South Gate of railway station is still blocking the smooth flow of water and this is the main reason sludge and waste accumulates in the 140 meter box culvert under the railway lines inside station premises.

Figure 17 The level difference at the outlet of 140 m Box culvert

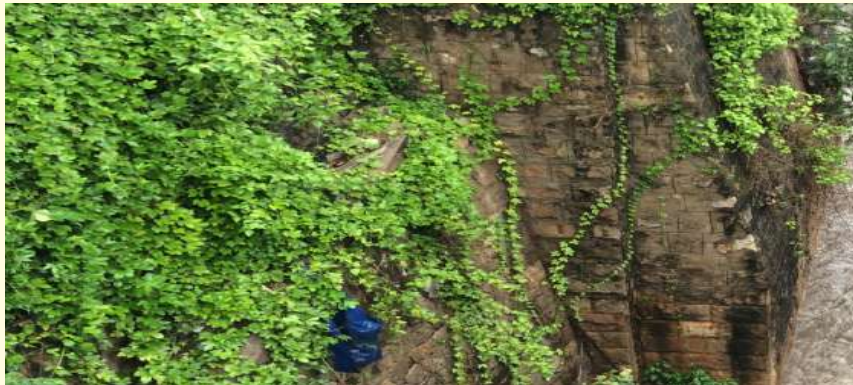
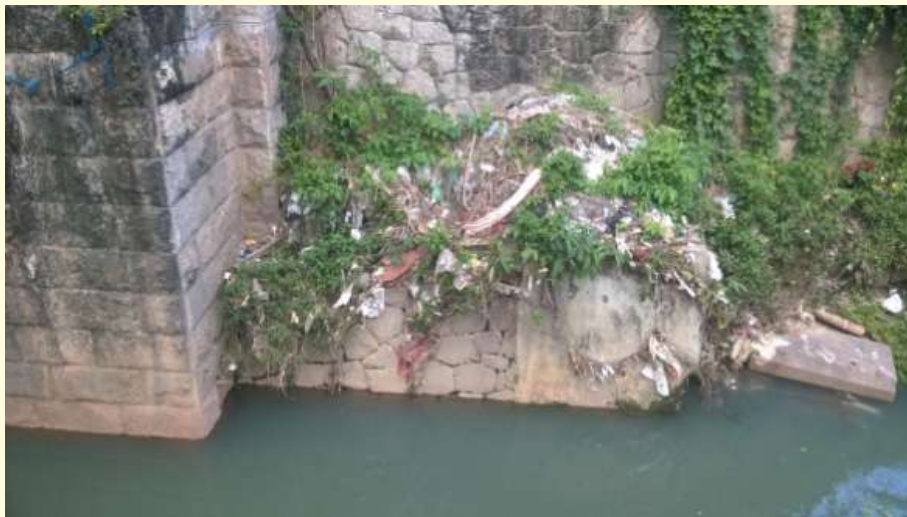
4. The abutment of old Uppidammoodu bridge restricts the width of the channel from 3 meters to 1 meter.

Figure 18 protruded abutment at Uppliamoodu

Figure 19 protruded abutment at Uppliamoodu

The above-mentioned blockades are to be removed immediately to facilitate free flow of water through the canals. Therefore, in order to have a permanent solution to the issue of flooding in the city of Thiruvananthapuram, atleast the blockages listed above have to be removed in a time bound manner once rain is over.

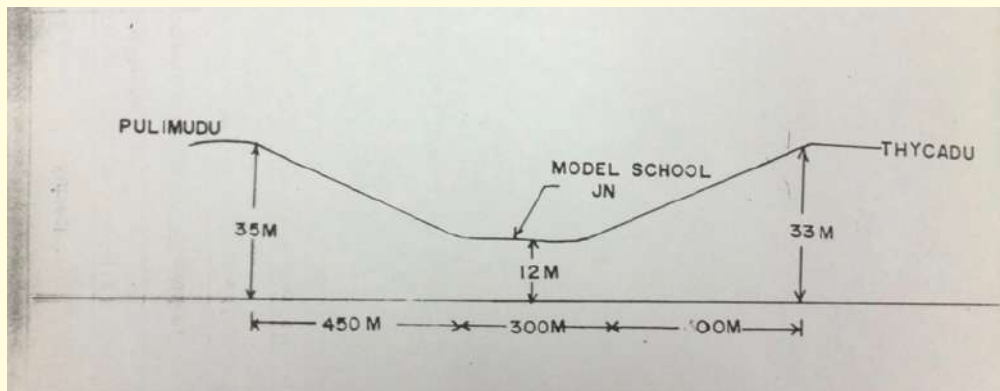
As part of this, two other activities were also planned in its phase II operations. The Secretariat and adjoining buildings are situated on the top of a hill. Similarly, the Arts College, Women's College, etc are on the top of another hill nearby. In between these two hillocks, there is a valley and the road to Thampanoor from Palayam via Bakery Junction pass through this valley. (Please see sketches attached).

Figure 21 The trough created by two Hillocks

The huge quantity of storm water collected in the compound of Secretariat, its two annexes, central stadium etc during the rainy season, reaches down to this valley portion and flows finally into the Amayizhanjan Thodu towards Thampanoor. As an alternative to this, the entire quantity of water can be collected in an underground reservoir in the Secretariat compound or central stadium and then pumped to Kunnukuzhi area through pipe. Similarly, the rain water from the other hillock consisting of Govt Womens college, Xanadu and other ministers Bunglows, police parade ground, Govt Arts college and model school could be diverted to Killiyar river, near Jagathi – towards the east. Thus, if these two streams of rainwater collections are prevented from reaching Thampanoor, it is certain in that the place will never get flooded.

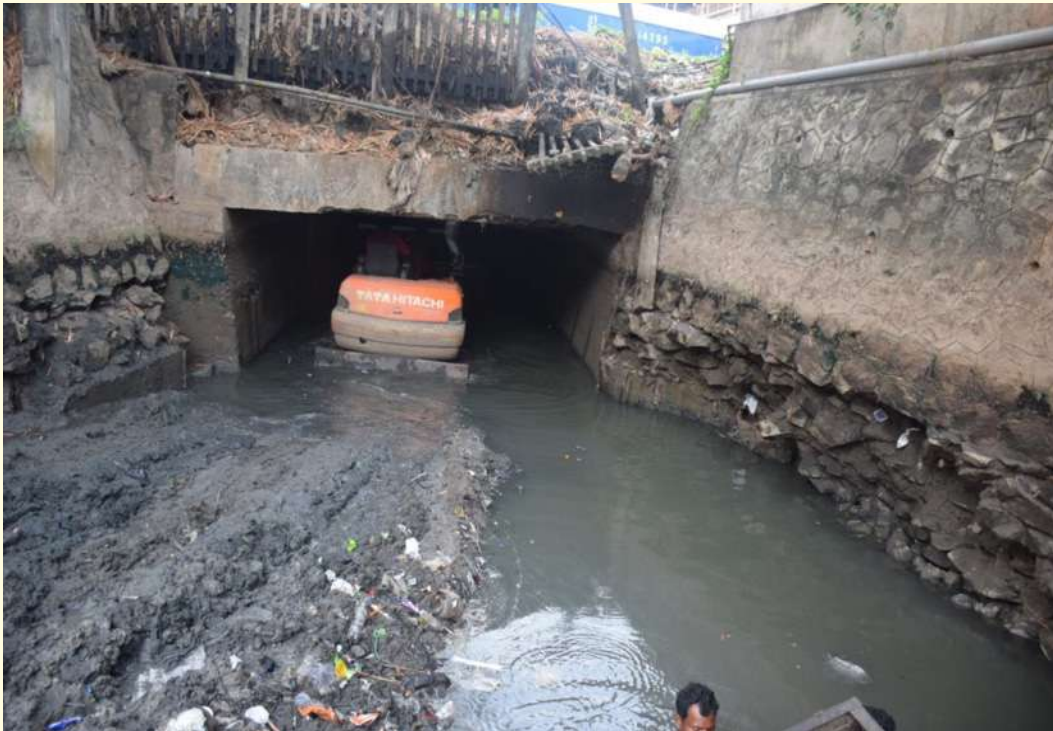
The canals including the box culvert in the railway compound were widened with an aim that they could be cleaned with the help of machines. The drains now are wide enough to allow bulldozers or excavators to push the sludge and waste outside to convenient locations, from where it could be loaded to lorries and taken away. There are remotely operated bulldozers, which will be more effective than the manually operated ones to move waste inside confined spaces. In short, the width of 3 m and above has been provided in almost all sections of the canals just for facilitating the entry of the cleaning machines.

Figure 22 The excavator can pass through the box culvert under railway lines
